STRUCTURAL INTEGRITY ASSESSMENT OF A FIRE DAMAGED PROCESS COLUMN

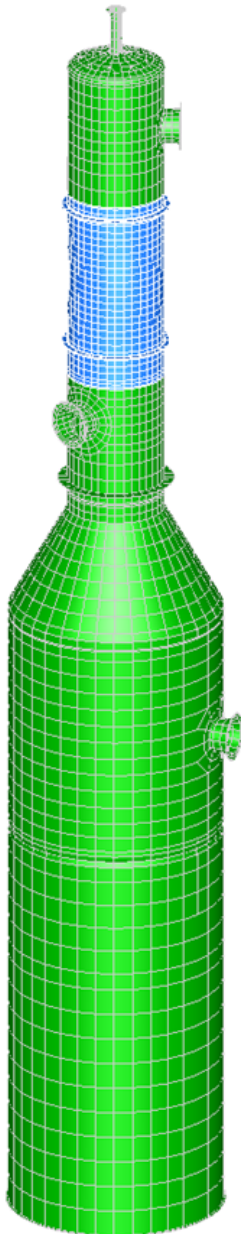
Structural integrity assessment of existing plant is often required following the discovery of excessive corrosion or other damage. In one such project, undertaken for the operator of a large oil refinery located in the south of England, FCL carried out work to establish the significance of two major deviations from design shape, taking the form of a “bulge” and an “indentation” in the upper shell of a process column, which were caused by a pyrophoric scale fire.

The findings of the work, which were underwritten by a series of supporting design code calculations and input from metallurgists, who provided mechanical property data for the fire damaged material, confirmed the integrity of the column for continued operation and thereby avoided the need for costly repair work which would have required the column to be taken out of service and would have resulted in a consequent adverse impact on refinery throughput.

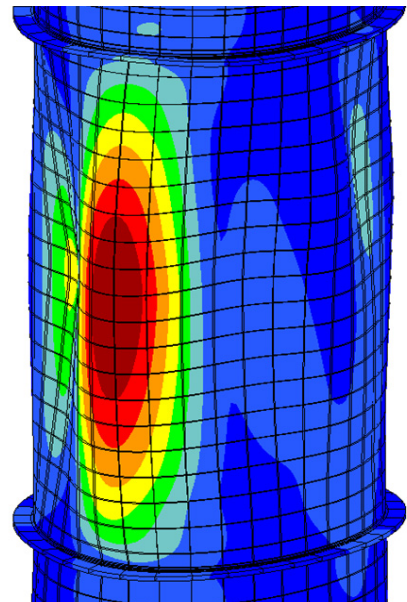
The principal objective of the investigation was to determine whether the increased stress levels caused by the presence of the “defective” areas could be safely accommodated and whether there was sufficient excess thickness available to avoid the premature onset of buckling in the upper shell. The assessment considered the combined influence of internal and external pressures, self weight, contents weight, wind loading and loads from attached piping, and was based on results obtained from Pro/MECHANICA (now CREO/Simulate) linear elastic stress and linear eigenvalue bifurcation instability buckling analyses, carried out using a detailed three-dimensional finite element model of the entire column. Faithful representation of the defective area in the model was achieved via input of a ‘cloud’ of point coordinate data obtained from detailed measurement of the actual geometry, which was then used to generate a series of smooth spline curves for surface lofting.
