## **LIFE EXTENSION OF AIR RECEIVERS FOR WIND TUNNEL FACILITY**

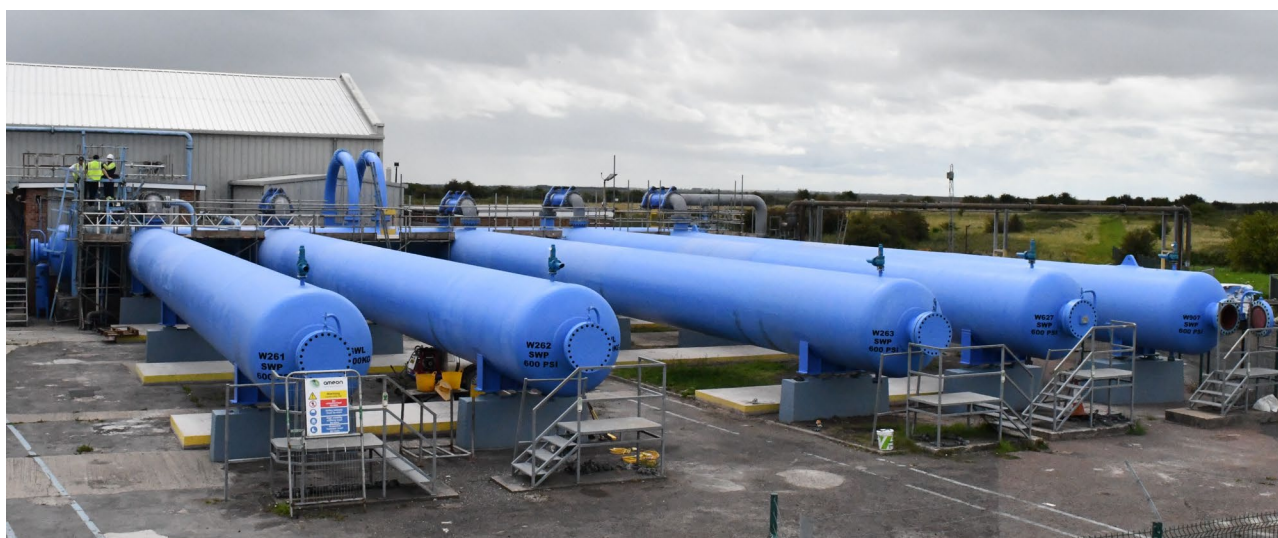
The experience gained by FCL staff in all aspects of pressure vessel engineering enables us to offer wide ranging support when assessing the adequacy of ageing and/or damaged plant for continued operation. In a recent case, FCL were approached by a client who wished to prolong the operational life of a set of six large air receivers which provide a reservoir of compressed air for a hypersonic wind tunnel facility. The vessels, each measuring approximately 26m in length (tan-tan) by 1.8m in diameter, were of varying age with the oldest items dating back to the 1950's. Contemporary design codes offered little or no guidance on fatigue design, raising valid concerns about the safety of the vessels for continued operation in cyclic service. These concerns were exacerbated by the discovery of cracking in fillet welds attaching the support saddles and internal bracketry to the vessel shells, together with areas of external corrosion.
